# Manhole Inspection Summary

Manhole # S31II\_010MH

Insp Date: **4/6/07 11:12 AM**

**Location** Address: **121 MOSHER ST**

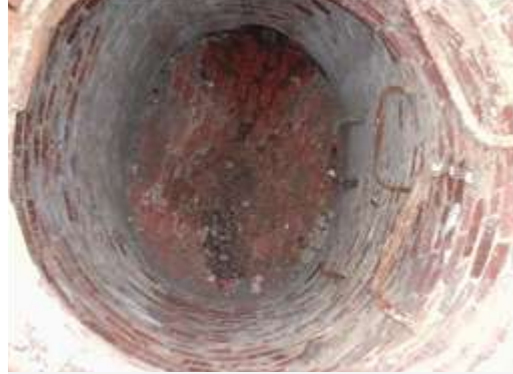
Top View

Corroded and missing steps. Channel debris.

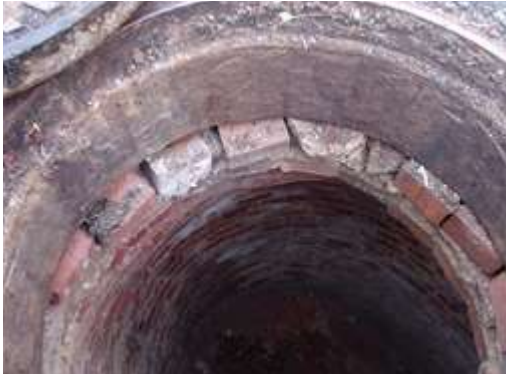
Defect

Frame leaks. Frame offset. Adjustment deterioration, loose brick and infiltration. Barrel infiltration - other side.

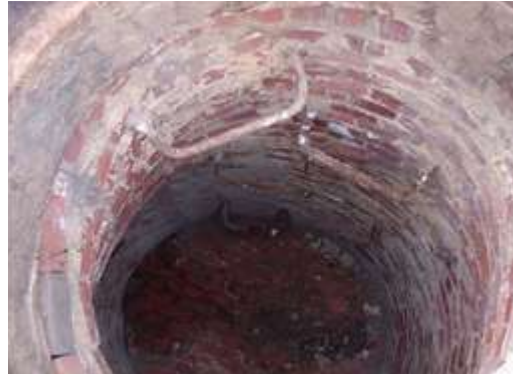
Defect

Frame leaks. Frame offset. Adjustment deterioration, loose brick and infiltration. Barrel infiltration.

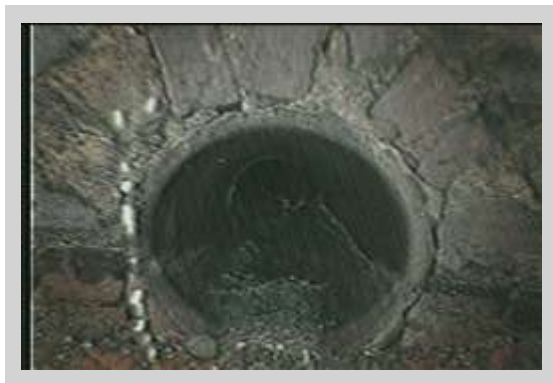
Pipe Out @ 12 O'Clock

Barrel deterioration and infiltration.
